RE: Request for Information (“RFI”) Pursuant to Section 308 of the Clean Water Act  
Compliance Evaluation Inspection Report (“CEI”) conducted on April 4, 2016  
ACE Auto Parts Inc.  
Docket No. CWA-IR-17-005

**COMPLIANCE EVALUATION INSPECTION REPORT**

<b>Compliance Evaluation Inspection:</b> ACE Auto Parts, Inc.	
<b>Inspection Date:</b> April 4, 2016	<b>Inspection Time:</b> 11:30AM – 1:15PM
<b>EPA Inspector:</b> Cyndy S. Kopitsky, Environmental Scientist, USEPA Region 2, DECA, Water Compliance Branch (212) 637-3832 & Andrew Dinsmore, Stormwater Team Leader USEPA Region 3 (215) 814-2788	
<b>NJDEP Representative:</b> Sandy Crowley, 609-439-9537	
<b>On-Site Representative:</b> Domenic Monarco, 856-365-4778/ 609-634-4383	
<b>Site Information:</b> ACE Auto Parts, Inc. 1999 Cooper Street Camden, New Jersey 08105  <b>Owner/Operator/Permittee:</b> ACE Auto Parts, Inc. 1999 Cooper Street Camden, New Jersey 08105  SPDES No. NJG0141984

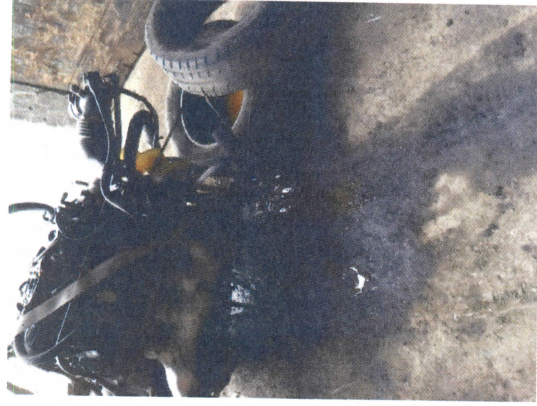
IMG\_2934

IMG2928	Engine Storage Area
IMG2929	Oil Spill/Leak Storage Area
IMG2930	Storage Area
IMG2931	Battery Storage
IMG2932	Storage Area
IMG2934	Storage Area
IMG2935	Covered Storage Area
IMG2936	Covered Storage Area
IMG2937	Storage
IMG2938	Leaking Oil Bucket
IMG2939	Leaking Oil Bucket
IMG2940	Storage Area

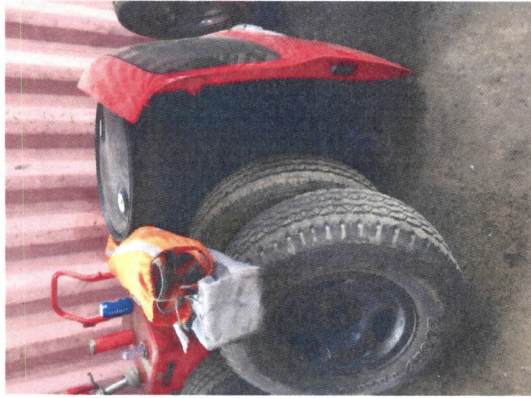
IMG\_2941

ground, some partially covered, some leaking, fluids spilled on the ground and under engine parts, and uncovered vehicle fluids in unmarked containers, therefore in violation of Parts IV.C.5.a-d. of the permit

IMG2941	Unmarked Drums
IMG2943	Entrance View
IMG2944	Oil drums
IMG2946	Cylinder Storage/Ground oil spills
IMG2948	Oil Storage
IMG2950	Oil drum
IMG2952	Oil drum
IMG2953	Gated area, side of property
IMG2954	Parts and storage
IMG2955	Scrap
IMG2957	Scrap outside open dumpsters
IMG2958	Storage
IMG2959	Trash/storage
IMG2961	Trash
IMG2962	Spill
IMG2963	Oily soil conditions
